Home Inspection:

**6 Non Such Pl
New Castle, DE**

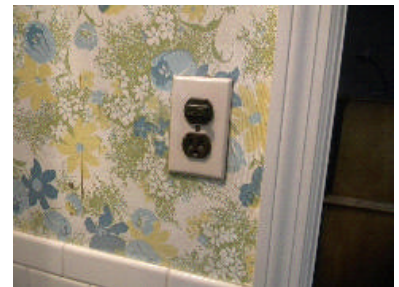
Repair: The bathroom did not have a gfci outlet we recommend repair as required.

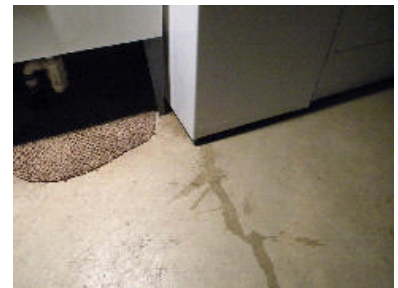
Further Review: The washer leaked when operated using the normal operating controls. We recommend repair or replacement.

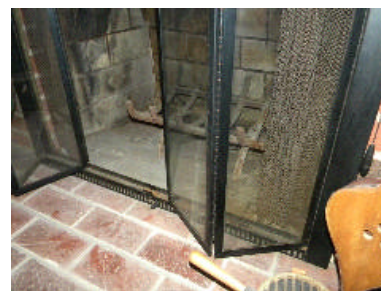
Repair: We found the door difficult to operate. We recommend that the damper be repaired to restore normal operation.

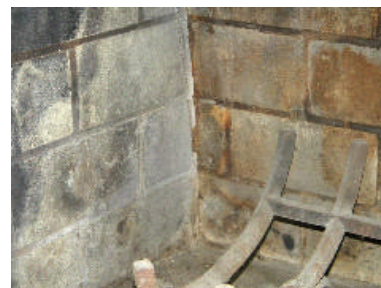
Repair: The mortar in the fireplace was soft and or damaged. Repair is recommended to extend the service life of the firebox.
