Home Inspection:

**6 Non Such Pl
New Castle, DE**

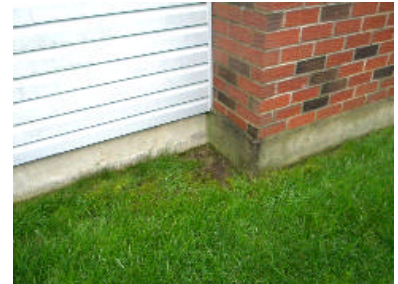
Monitor: The slope of the general site grading away from the structure was minimal. We recommend monitoring site drainage performance with repair as necessary.

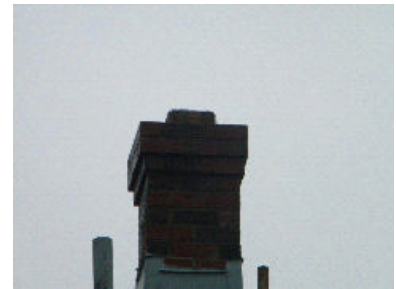
Recommended Upgrade: A spark arrester and/or rain cap should be installed on the chimney flue stack top. This is a safety issue and should be addressed. We recommend that a spark arrester and/or rain cap be installed as an upgrade from its original configuration.

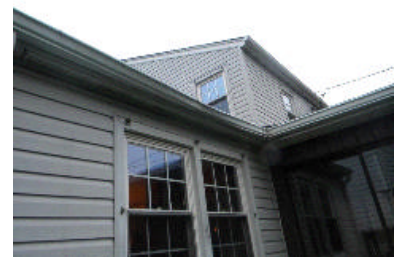
Maintenance: The downspouts of the gutter system should be routed away from the buildings foundation. We recommend that the runoff be directed six feet away from the foundation. **Repair:** Sections of the gutters were damaged on one or more sides. We recommend that all damaged, rusted or rotted gutters should be repaired or replaced in accordance with industry standards.

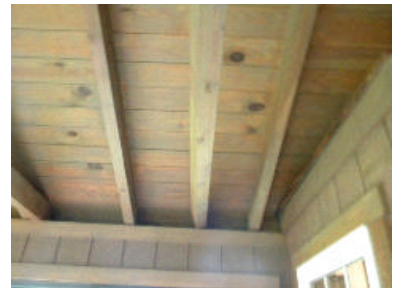
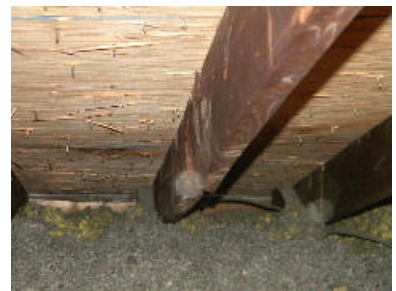
Repair: Broken framing members were observed in one or more areas of the roof structure. Attention to the broken members is required to keep the structure sound. We recommend further review for a better understanding of replacement/repair costs and present condition.

Repair: Sagging framing was noted in one or more areas of the porch roof structure. Attention to the framing is required to keep the structure sound. We recommend further review for a better understanding of replacement/repair costs and present condition.

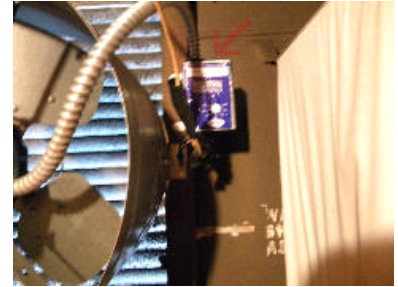
Further Review: A vent fan was observed in the attic space, however it was not tested. We recommend further review for a better understanding of present condition. **Repair:** The wire for the attic fan is connected with an extension cord. This is a safety concern and should be repaired as required.

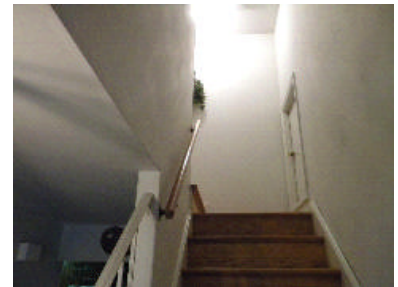
Safety Concern: The railings on the interior stairs were found to be loose. We recommend that all loose railings be repaired to ensure safe and proper operation.

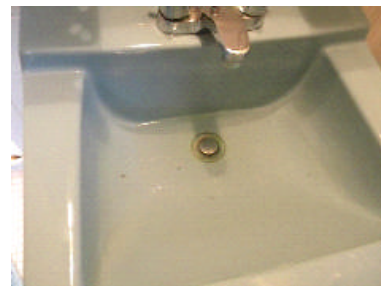
Repair: The hall bath wash basin drains were observed to be slow. We recommend correction as necessary.

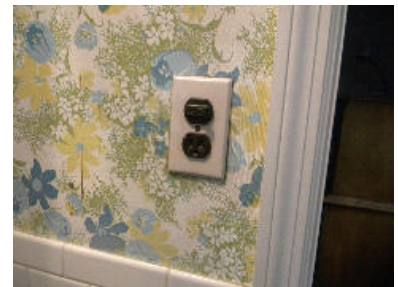
Repair: The bathroom did not have a gfci outlet we recommend repair as required.

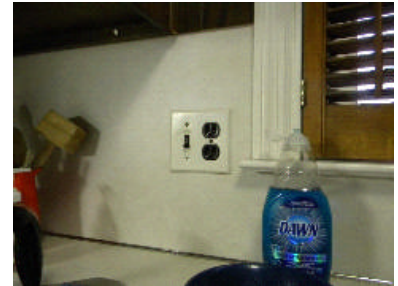
Repair: A ground fault circuit interrupter breaker (GFCI) was not installed for the kitchen as required. This could pose a serious safety condition and this shock protection device should be installed. We recommend that GFCI receptacle protection be installed according to current applicable standards as a safety upgrade wherever needed.

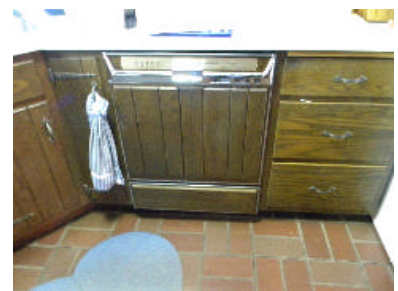
Repair: The dishwasher failed to respond to normal operating controls. We recommend correction as necessary.

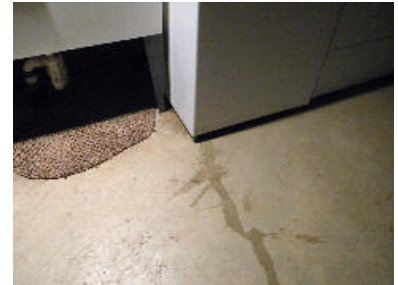
Further Review: The washer leaked when operated using the normal operating controls. We recommend repair or replacement.

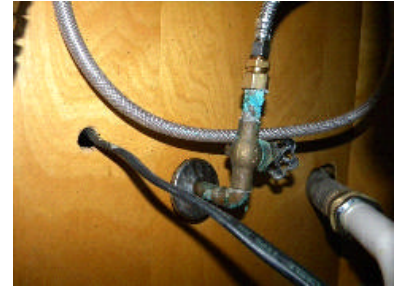
Monitor: There was evidence of surface corrosion, but no leakage, at the exposed and accessible supply piping. This piping should be monitored for leakage and repaired if necessary.

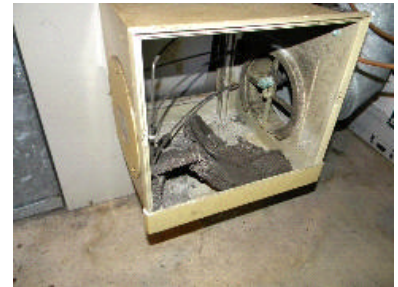
Further Review: The furnace appears to be older and may need replacement in the near future. We recommend that you budget for replacement.

Further Review: The heating unit was observed to have an associated humidifier. The humidifier was not in use at the time of inspection. The unit appeared to be abandoned or winterized. We recommend further review for a better understanding of replacement/repair costs and present condition.

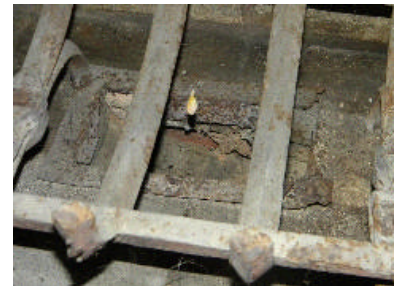
Repair: Our inspection of the fireplace revealed that the ash cleanout door was missing or damaged. We recommend repair of the door to keep out pests and moisture intrusion.

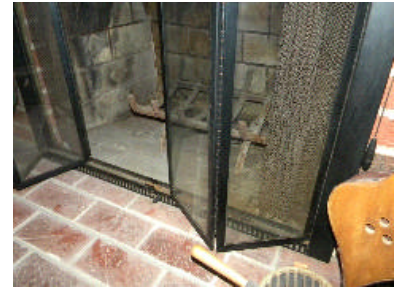
Repair: We found the door difficult to operate. We recommend that the damper be repaired to restore normal operation.

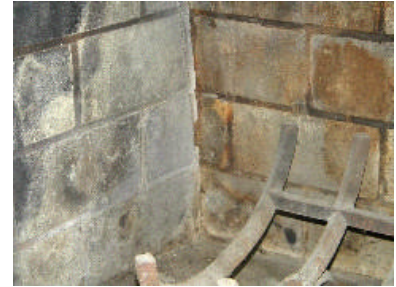
Repair: The mortar in the fireplace was soft and or damaged. Repair is recommended to extend the service life of the firebox.

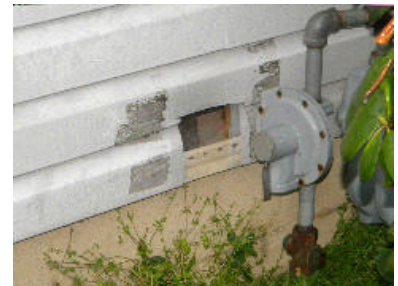
Repair: The exterior wall surfaces were in need of caulking at all cracks, gaps, and openings. Attention is recommended to guard against water intrusion, repair as necessary.
