PROPERTY INSPECTION

SUMMARY REPORT

The Sample Report
6 Non Such Pl, New Castle Delaware

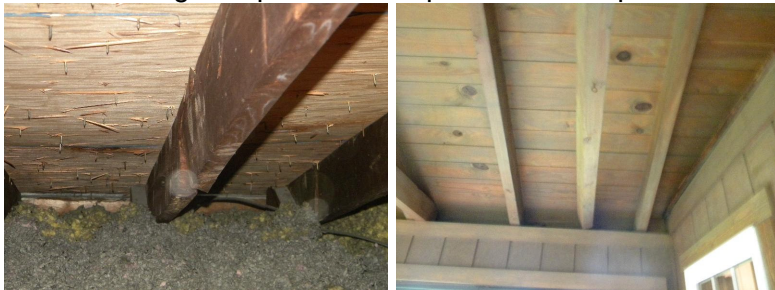
Roof Structure Condition

Repair: Broken framing members were observed in one or more areas of the roof structure. Attention to the broken members is required to keep the structure sound. We recommend further review for a better understanding of replacement/repair costs and present condition.

Repair: Sagging framing was noted in one or more areas of the porch roof structure. Attention to the framing is required to keep the structure sound. We recommend further review for a better understanding of replacement/repair costs and present condition.

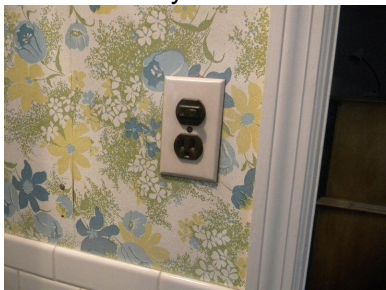
GFCI Condition

Safety Concern: The ground fault circuit interrupter breaker (GFCI) receptacle did not function as intended for the bathroom receptacles. This could pose a serious safety condition and we recommend that this faulty breaker should be replaced as soon as possible.

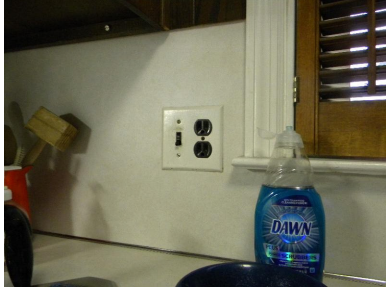
GFCI Location

Repair: A ground fault circuit interrupter breaker (GFCI) was not installed for the kitchen as required. This could pose a serious safety condition and this shock protection device should be installed. We recommend that GFCI receptacle protection be installed according to current applicable standards as a safety upgrade wherever needed.

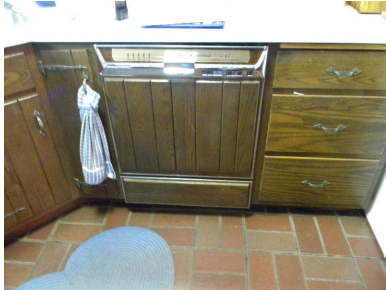
Dishwasher Conditions

Repair: The dishwasher failed to respond to normal operating controls. We recommend correction as necessary.

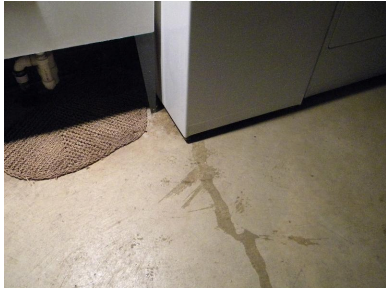
Laundry Conditions

Further Review: The washer leaked when operated using the normal operating controls. We recommend repair or replacement.

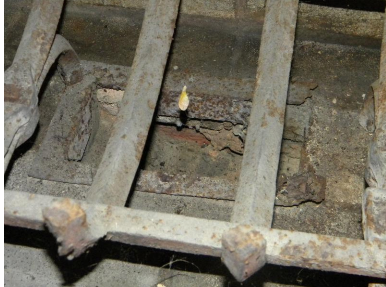
Fireplace Conditions

Repair: Our inspection of the fireplace revealed that the ash cleanout door was missing or damaged. We recommend repair of the door to keep out pests and moisture intrusion.

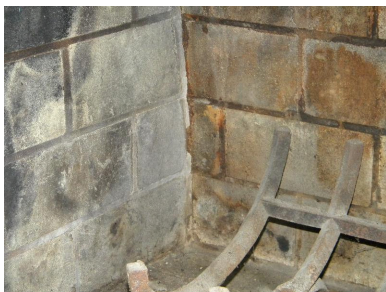
Firebox

Repair: The mortar in the firebox was soft and or damaged. Repair is recommended to extend the service life of the firebox.
