Confidential Inspection Report

LOCATED AT:
Leaf Ln
Felton, DE 19943

INSPECTED ON:
Monday, February 17, 2020

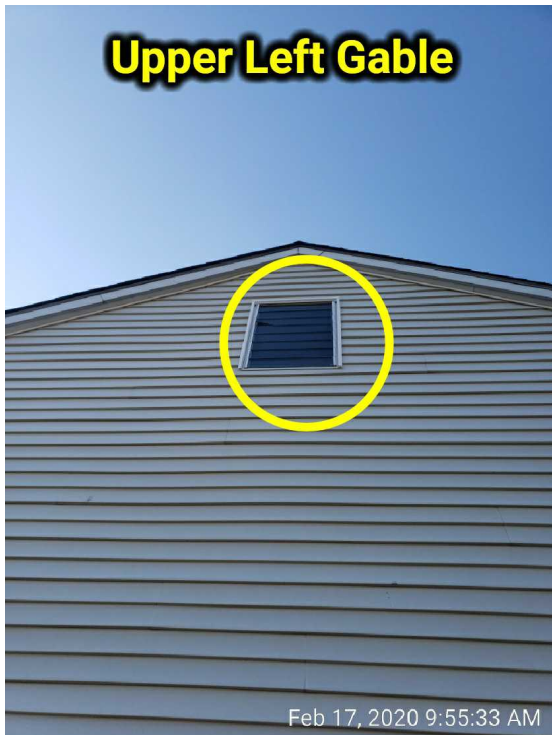
WINDOWS INTERIOR

REPA 1: Cracked or broken glass was observed in the basement. We recommend immediate replacement for all cracked or broken windows. This is a safety concern and should be addressed.

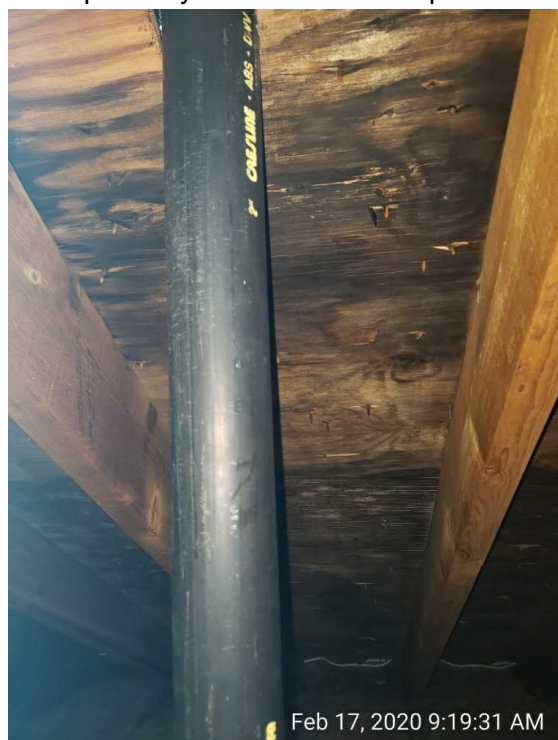
MOLD INTERIOR

REPA 2: A mold like substance or growth was observed at the attic. We recommend repair or replacement as required by a licensed mold specialist.

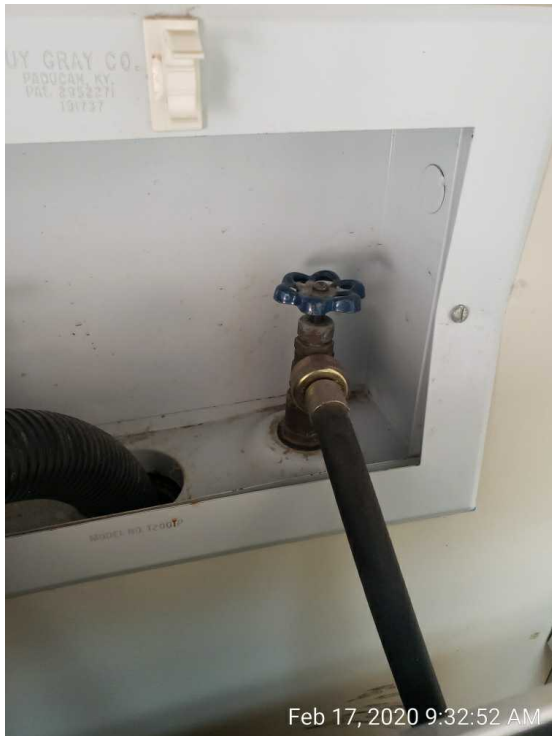
LAUNDRY PROVISIONS LAUNDRY AREA

REPA 3: Frozen in place water valve(s) were observed in the laundry area at the washer supply bib. Attention to the water valves is required in order to shut water off to the appliance. We recommend that any leaking valve be repaired or replaced as required.

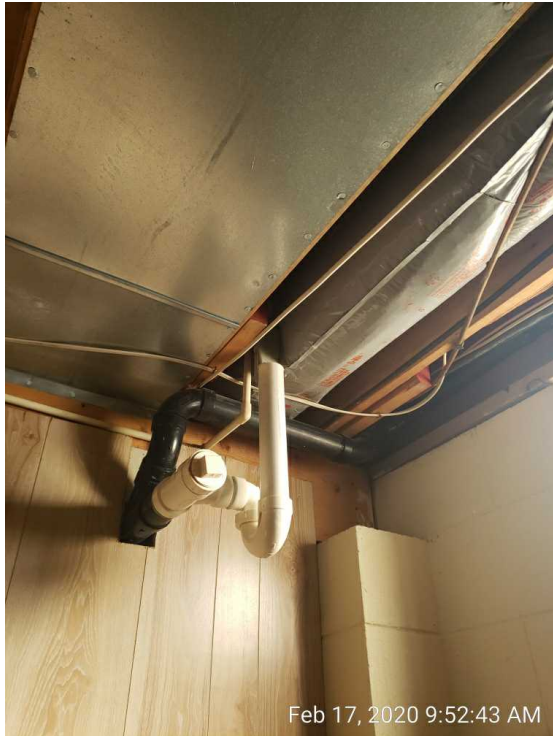
DISTRIBUTION PIPING PLUMBING SYSTEM

REPA 4: The water discharge from the softener tank was observed to be connected directly to the DWV pipe without an air gap. We recommend that the line be properly installed per manufacturers installation recommendations as required.

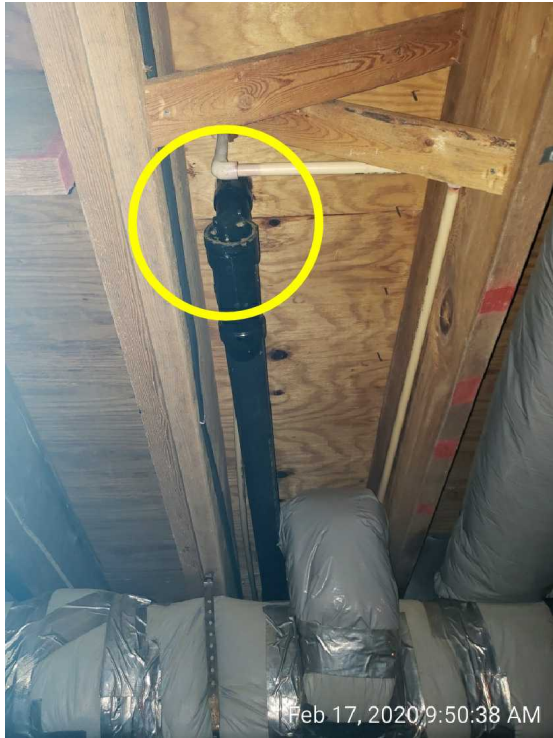
DRAIN WASTE VENT PIPING PLUMBING SYSTEM

REPA 5: Leaking drain/waste pipes were observed. Attention to the leaking pipes is required for damage control as well as health issues. We recommend that the leaks be repaired as required.

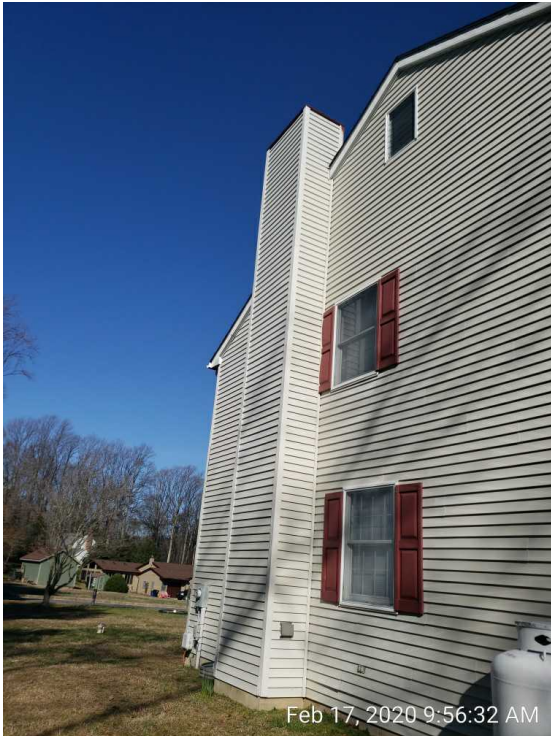
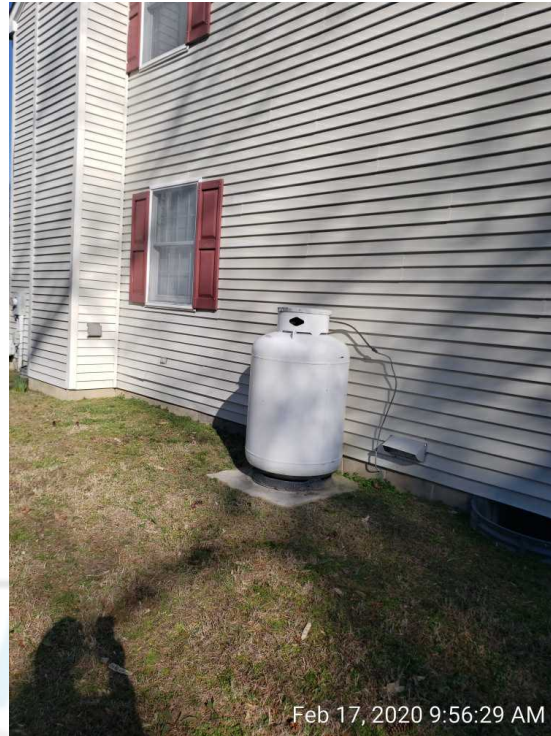
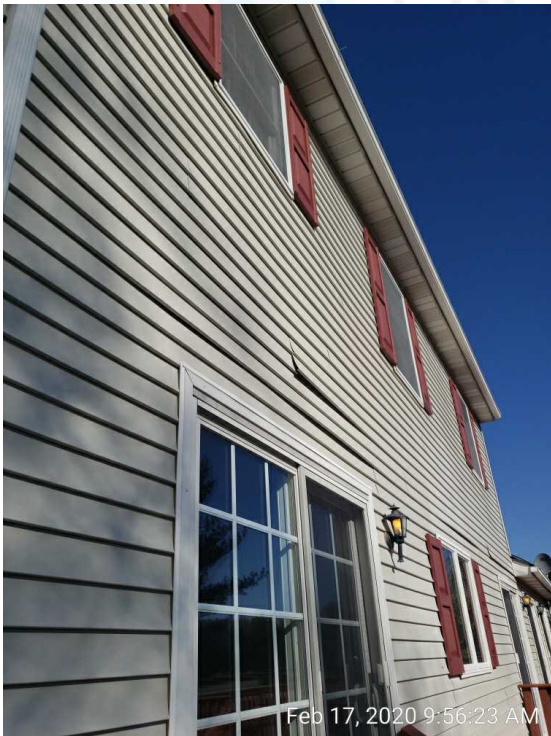
ACU-EXTERIOR WALL EXTERIOR WALL CLADDING

REPA 7: Loose siding was observed at the exterior wall surfaces. Attention to the loose siding and/or damage is required to keep out water intrusion and pests. We recommend repair to current industry trade standards as required.

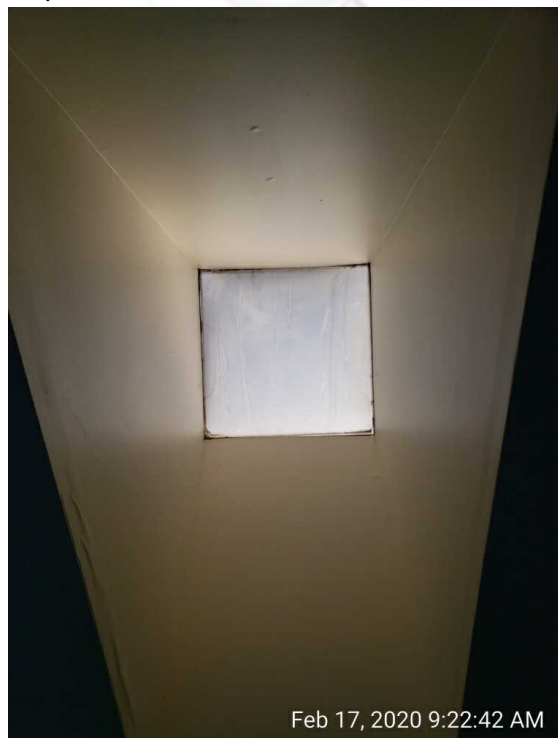
SKYLIGHT CONDITIONS

Condensation was noted between the skylight lens panels. We recommend repair or replacement as required

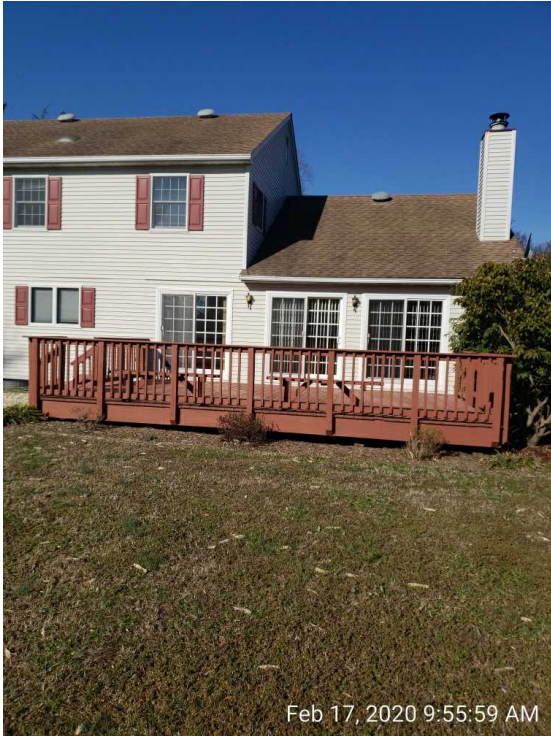
MATERIAL

The chimney was observed to be constructed with Sheet metal flue(s) surrounded by a wood frame and covered with vinyl siding.

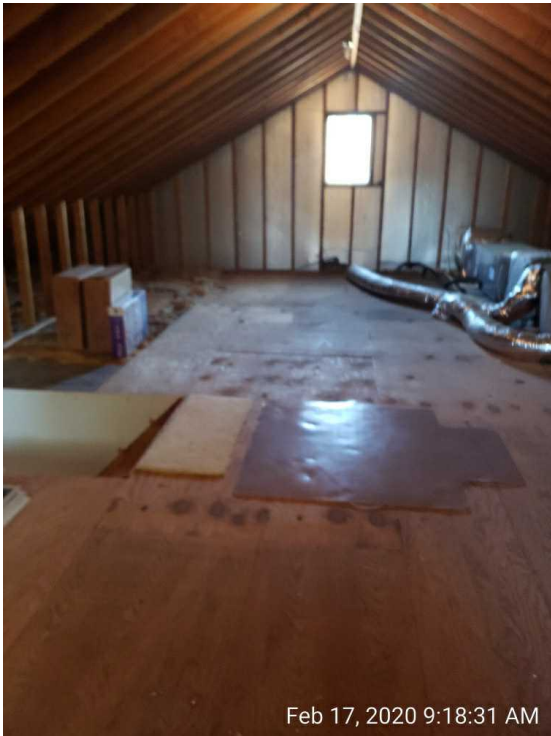
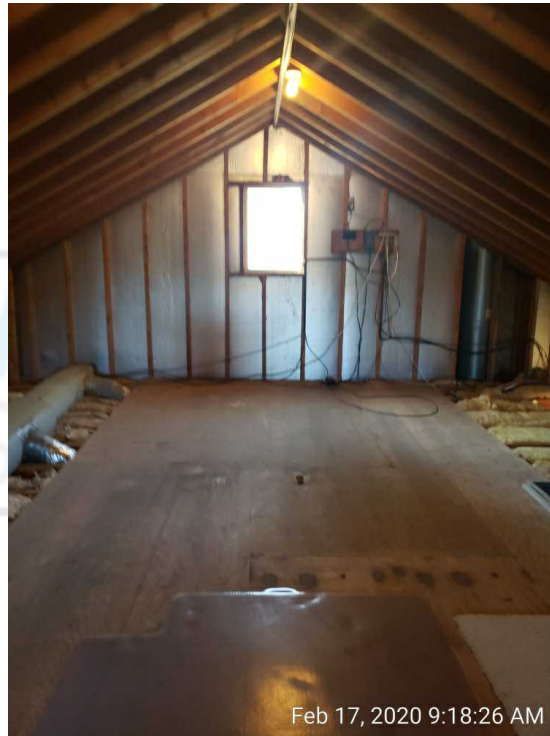
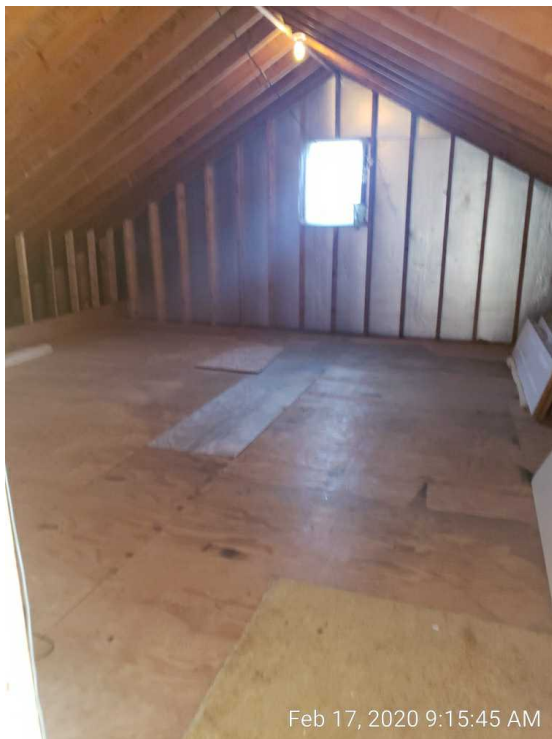
ENTRY - ACCESS DOOR/HATCH/LADDER

The inspector had limited access to the attic. Because of limited clearances and/or the potential for damage, our visual inspection of the attic was performed from the reasonably accessible areas only.

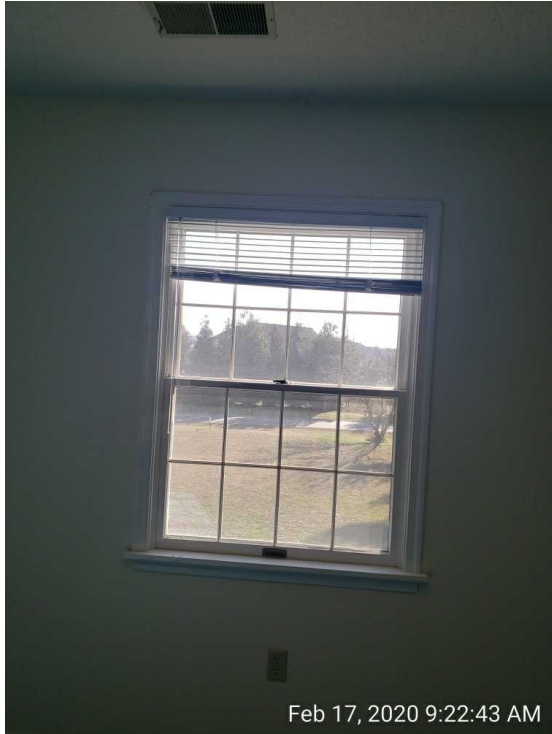
WINDOW CONDITION

MAIN Window screens at one or more areas were missing and/or damaged. We recommend that all damaged or missing screens be repaired or replaced to restore proper function.

The hardware on the windows was observed to be missing or broken. We recommend repair or replacement.

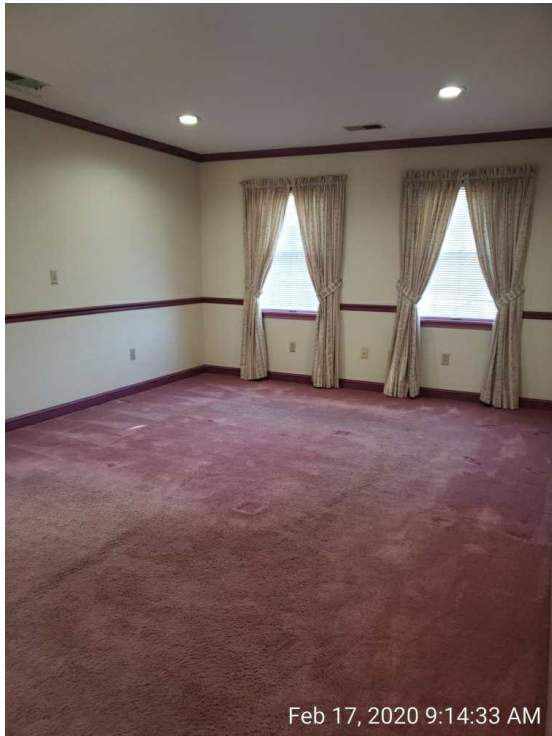
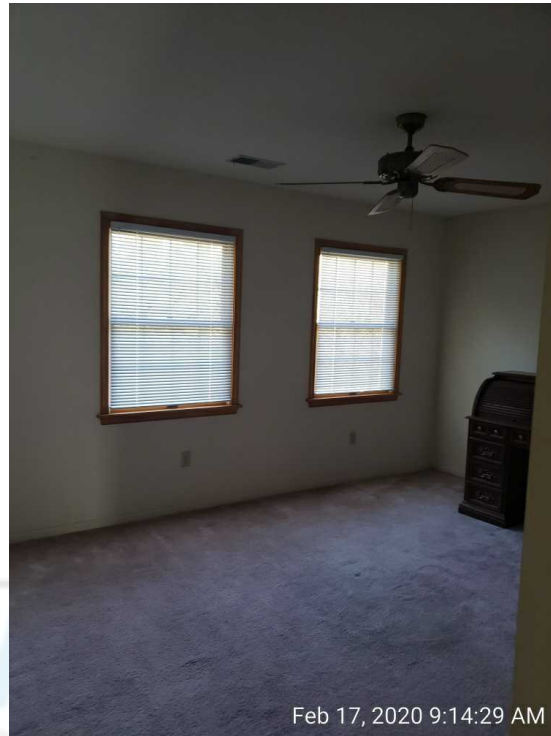
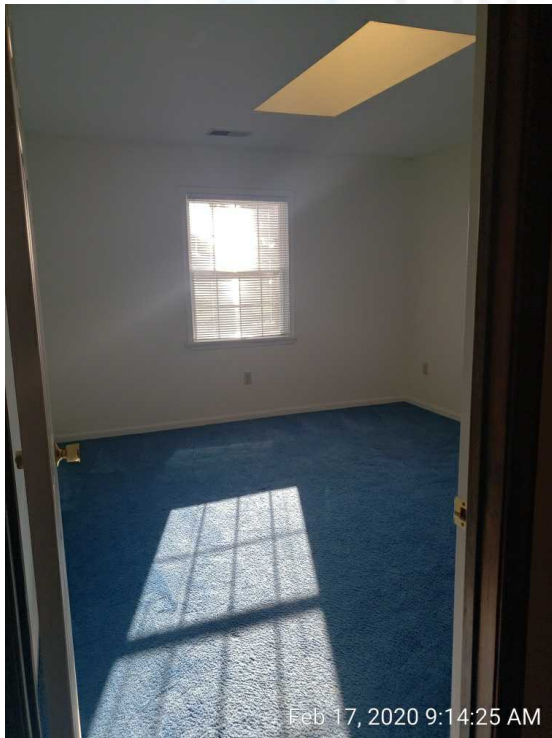
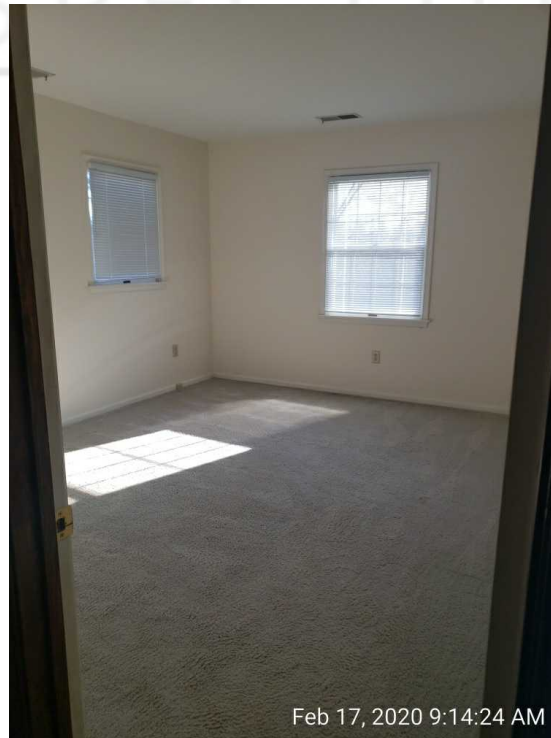
FLOORS

The interior floor coverings were carpet

The interior floor coverings were made of wood.

The interior floor coverings were ceramic tile

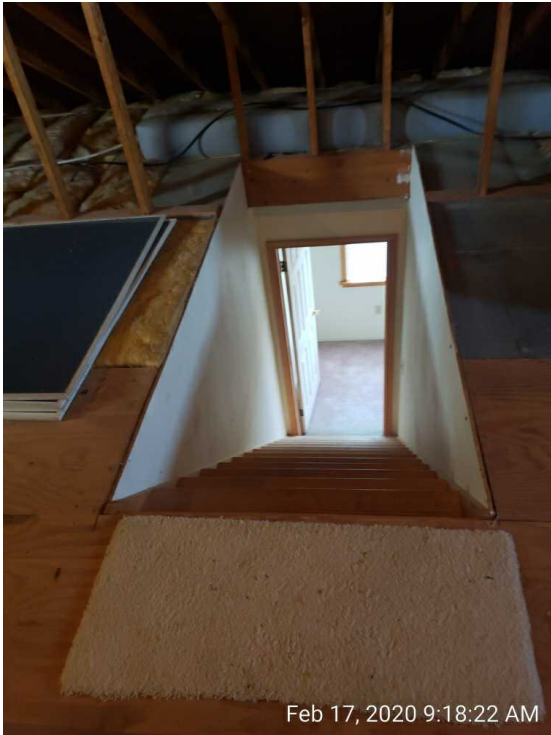
INTERIOR STAIRS

The stairs were used several times during the inspection. No specific deficiencies were noted at the time of the inspection.

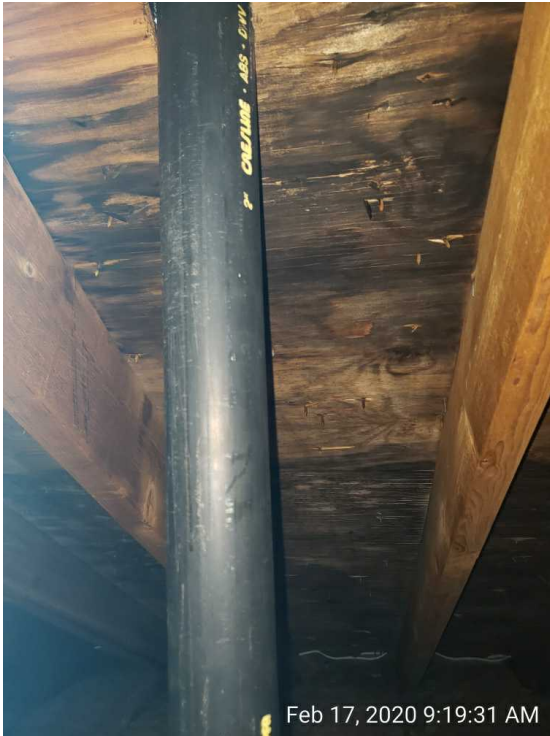
REPA A mold like substance or growth was observed at the attic. We recommend repair or replacement as required by a licensed mold specialist.

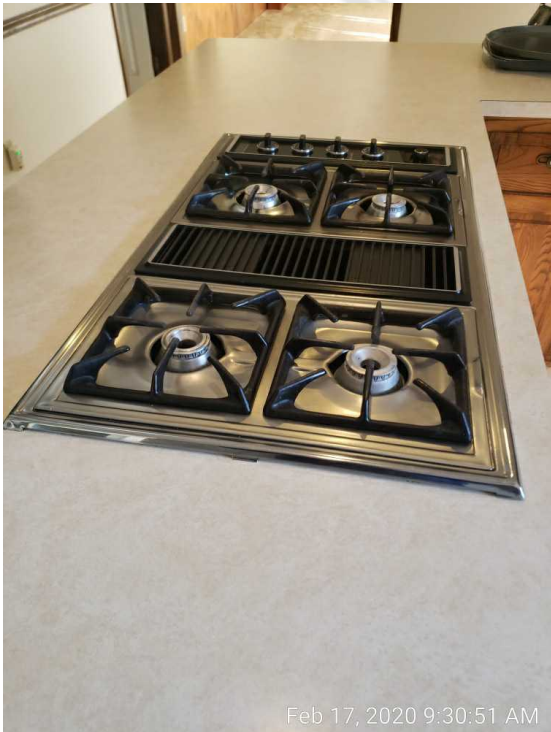
The gas cooktop/oven was turned on with normal controls and found to be operational. The oven if present was turned on with the normal operating controls (Bake and Broil). No tests were performed to determine the full range of heat settings, calibration or self-cleaning modes.

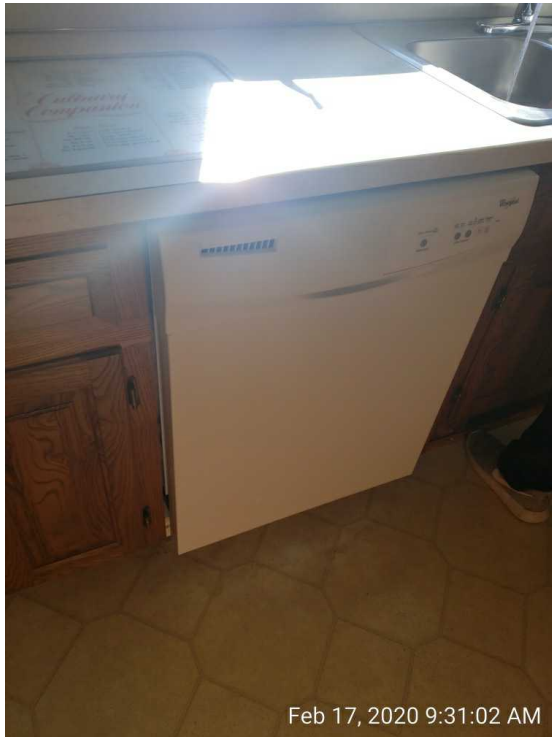
DISHWASHER

The dishwasher was operational and responded to normal operating controls. The dishwasher was run through a wash cycle and no leaks were observed. The dishwasher drain was equipped with an air gap or high loop in the drain line. This assures separation of the potable water supply from the sewer waste water and is an important health safety device or configuration.

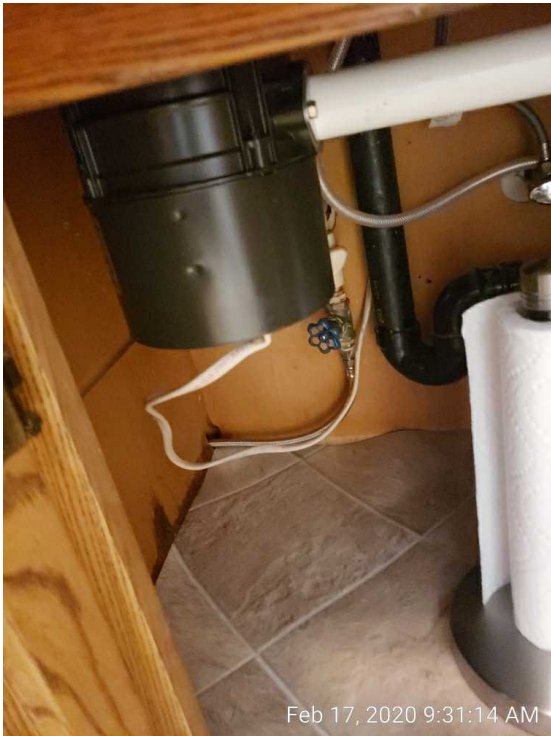
DISPOSAL

The garbage disposal was found to be operational and in generally acceptable condition.

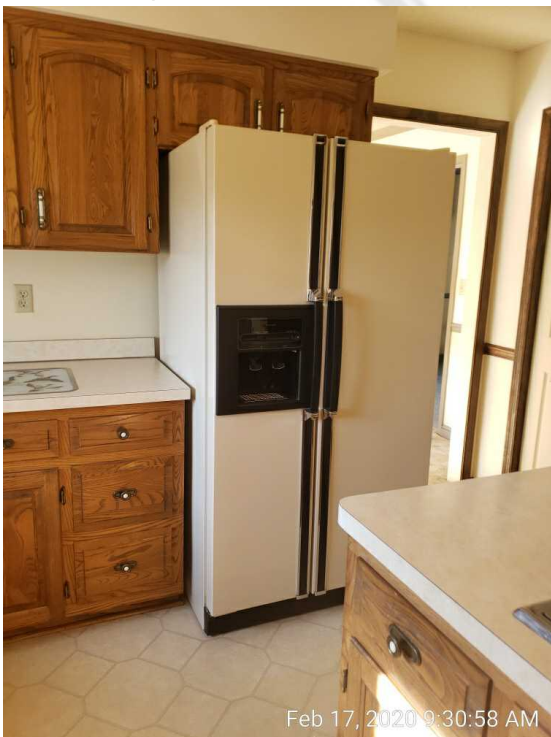
REFRIGERATOR

The refrigerator appears to be in operating condition. The gaskets were checked and the temperature was cool to the touch. The interior is in generally acceptable condition. The presence of an icemaker or the condition of an icemaker is not within the scope of a limited appliance courtesy check, this item if present was not inspected.

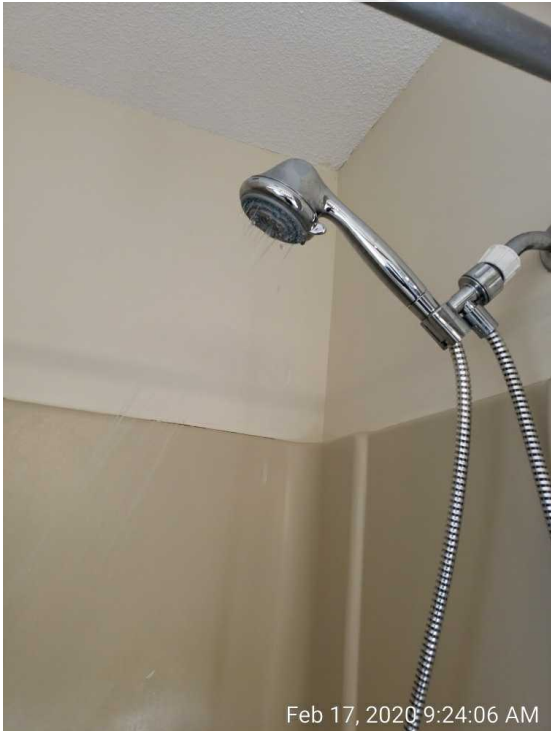
REPA Repair: The bath shower head was observed to be leaking at the connection to the shower arm. We recommend repair or replacement of the shower head to restore proper operation and use of the shower.

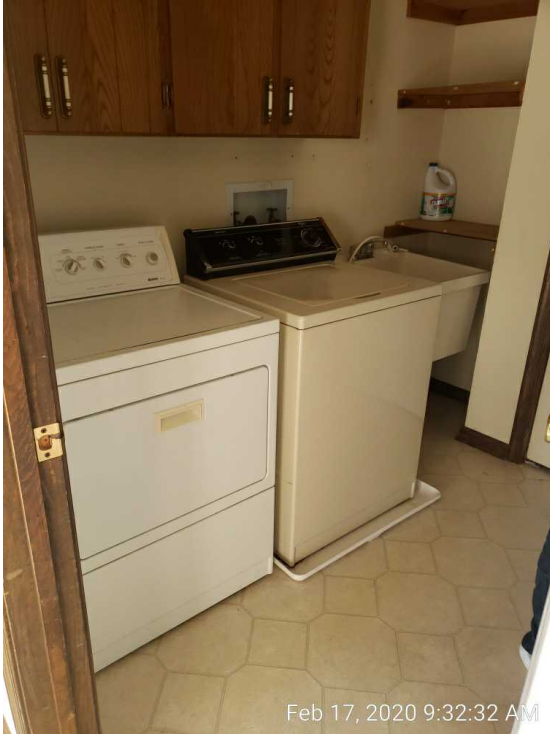
LOCATION - CONNECTIONS

Laundry provisions were located at an interior laundry area.

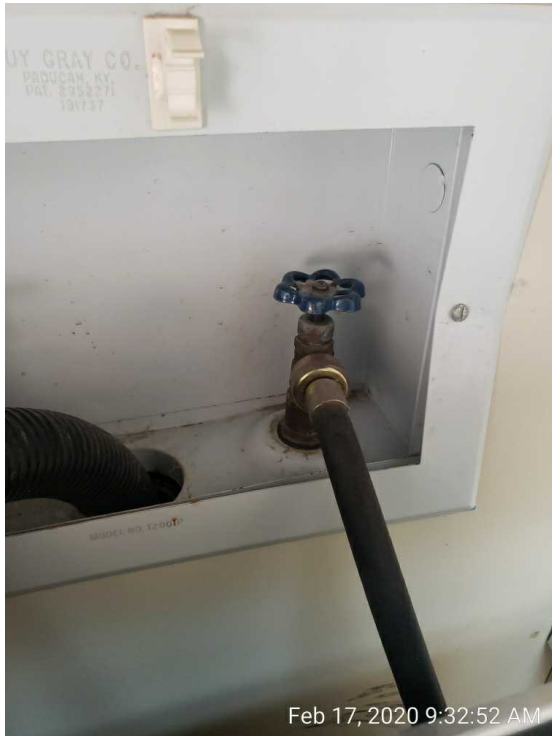
REPA Frozen in place water valve(s) were observed in the laundry area at the washer supply bib. Attention to the water valves is required in order to shut water off to the appliance. We recommend that any leaking valve be repaired or replaced as required.

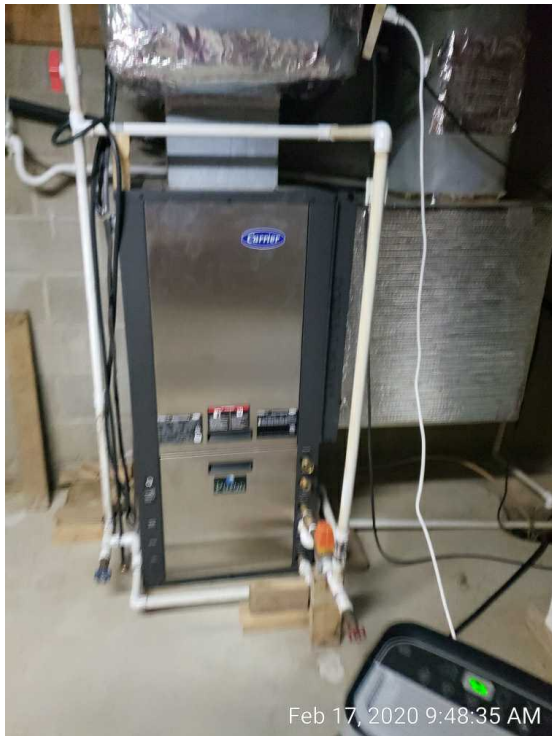
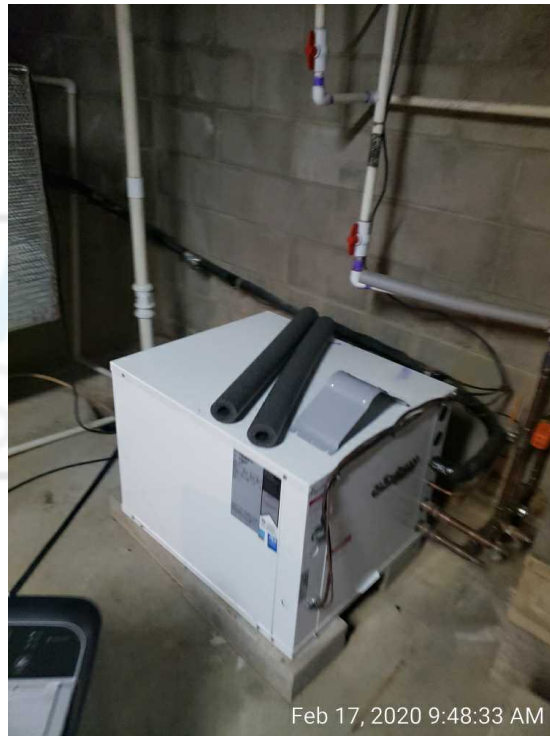
LOCATION

The location of the heating unit for this building was in the basement/crawl space.

The heating system is a water source geothermal heat pump

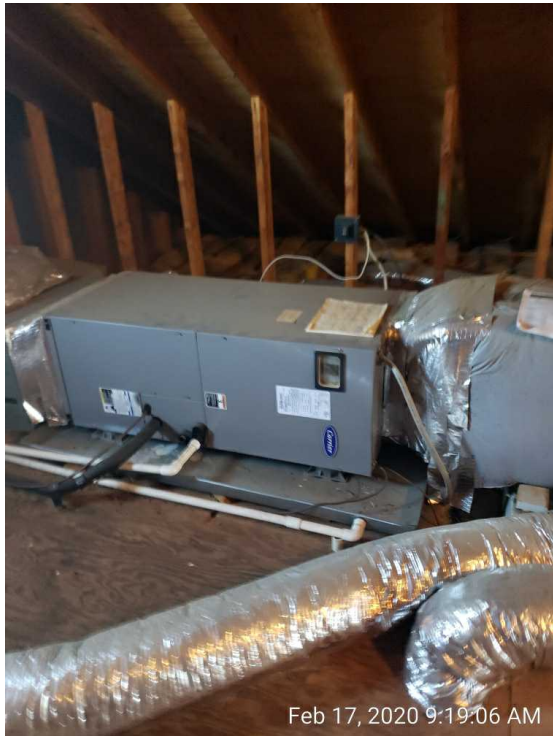
SECONDARY TYPE

The location of heating unit #2 was located in the attic.

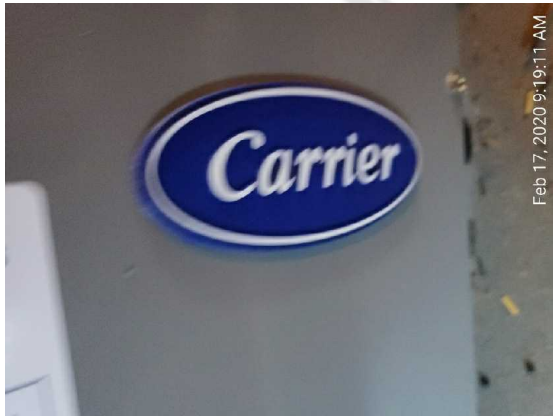
The name of the manufacturer or brand name for the heating unit(s) was.

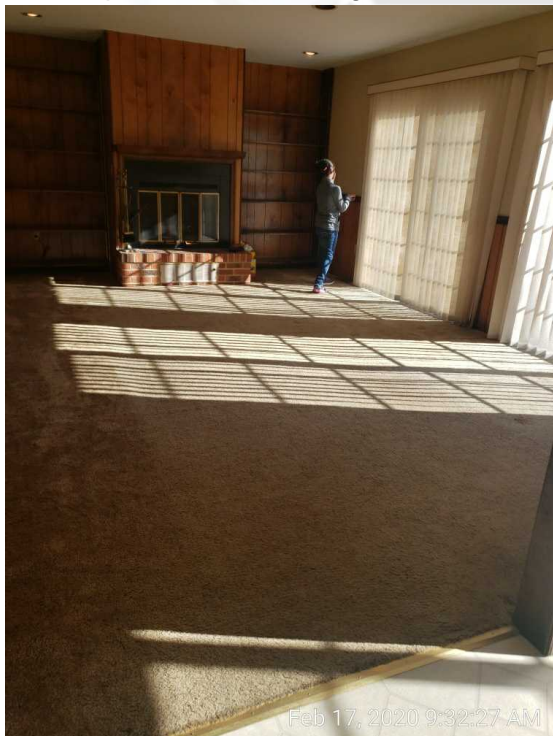
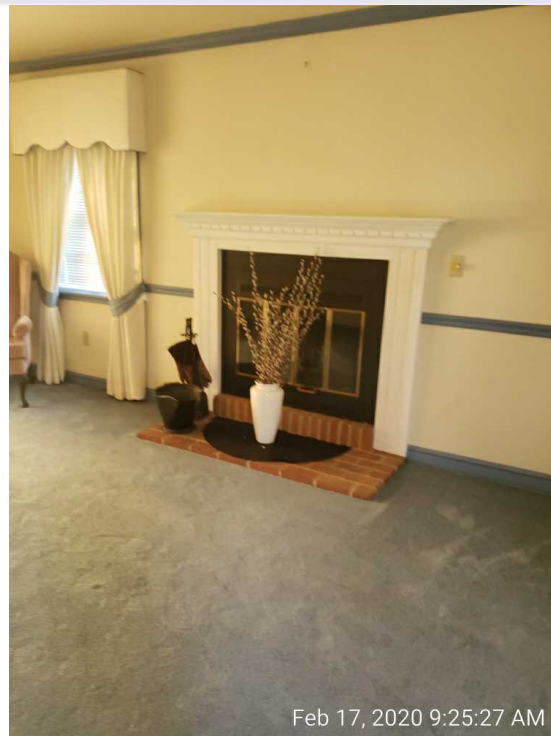
FIREPLACE TYPE

The fireplace in the building was a Masonry unit

The masonry fireplace and its components appears to be in generally acceptable condition. The following parts of a fireplace are not fully visible and therefore not inspected. The interior of flues and chimneys, fireplace surrounds, automatic fuel feed devices and heat distribution systems (gravity or fan assisted). National Fire Protection Association (NFPA) recommends what is known as a Level II inspection, including a video scan, by a qualified chimney specialist during real estate transfer. A Level II inspection may identify problems we can't see.

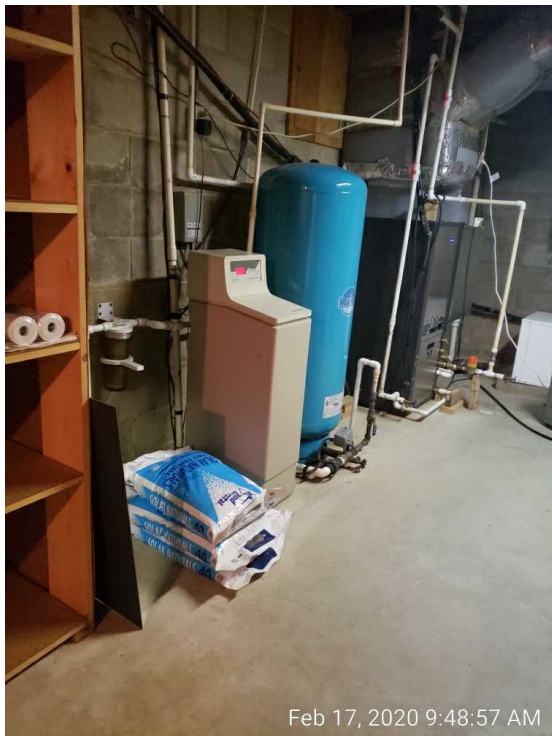
WATER SOURCE - WASTE LINE

Water for domestic consumption was provided by a private well or private community well system and the waste discharge was to a private septic system. We were unable to determine/verify the type of private waste system. We recommend that all private waste disposal systems be drained, pumped and certified for proper operation by a qualified septic systems contractor.

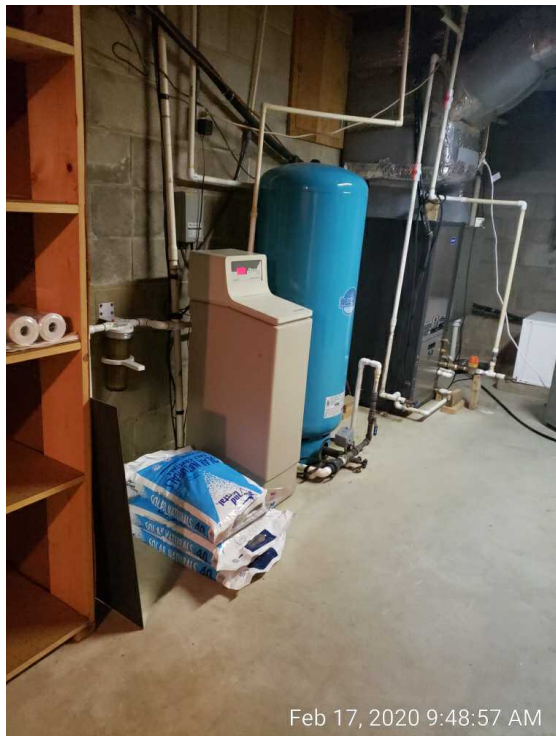
WATER SOFTENER

FURT A water softener was installed into the building's water supply. The softener appears to be in serviceable condition. The softener was not inspected and is not in the scope of a home inspection. We recommend further review for a better understanding of present condition.

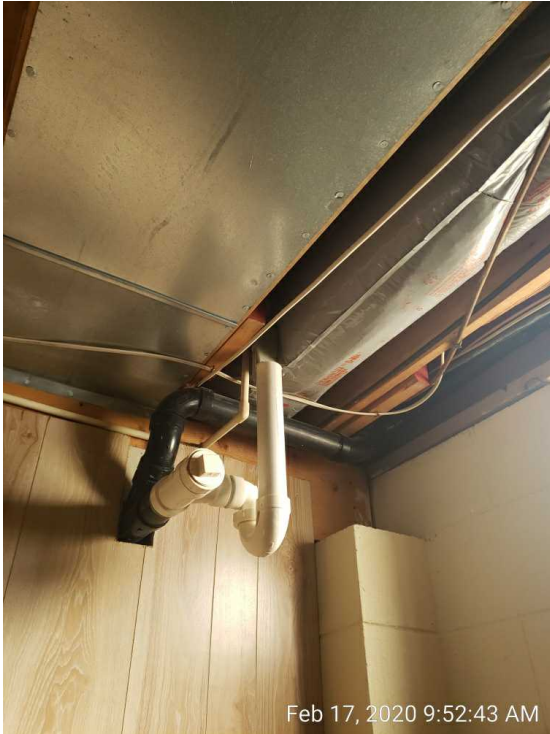
SOFTENER CONDITION

REPA The water discharge from the softener tank was observed to be connected directly to the DWV pipe without an air gap. We recommend that the line be properly installed per manufacturers installation recommendations as required.

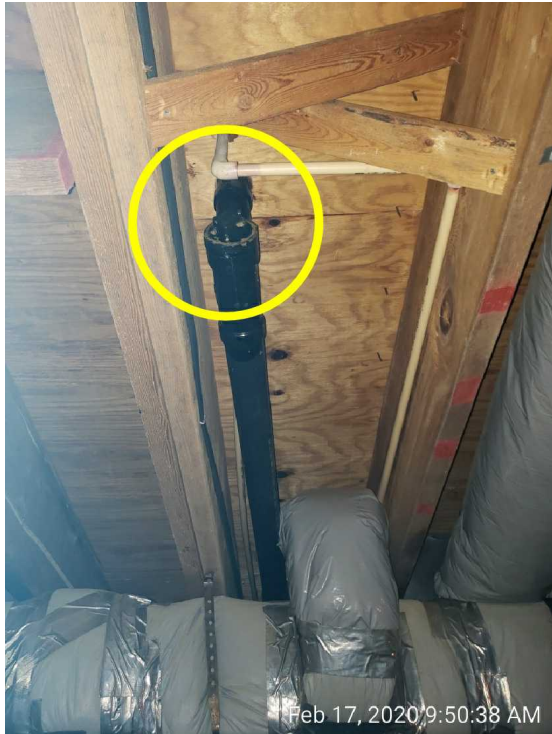
REPA Leaking drain/waste pipes were observed. Attention to the leaking pipes is required for damage control as well as health issues. We recommend that the leaks be repaired as required.

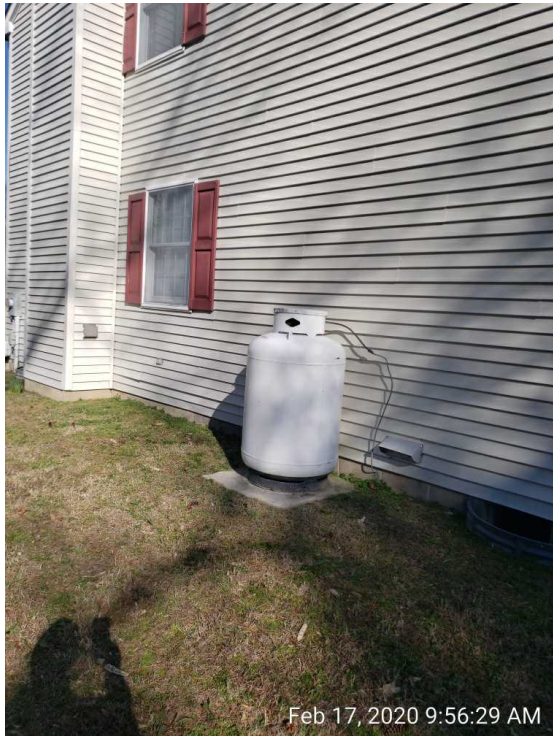
LOCATION

The LP gas shut off valve is located on the top of the LP storage tank on the right side of the property.

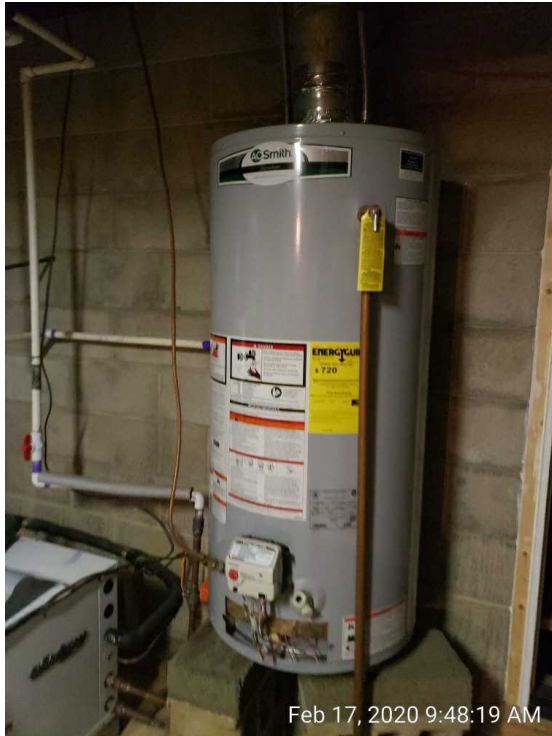
SINGULAR LOCATION

The water heater was located in the Basement

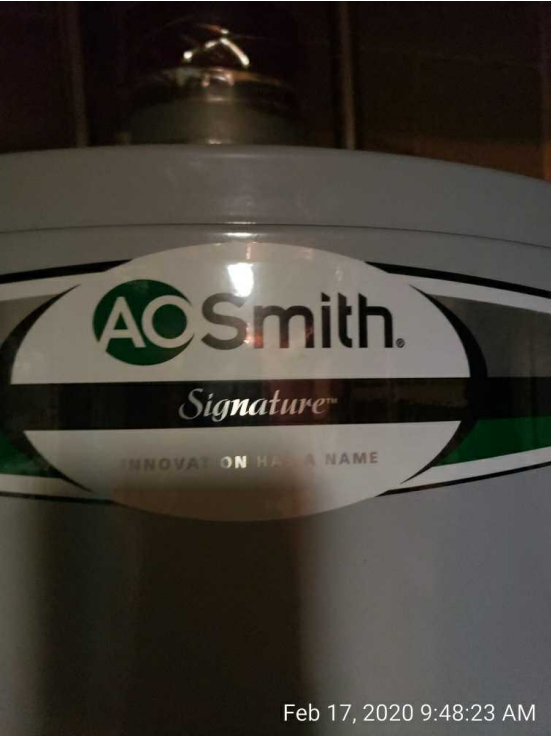
The name of the manufacturer or the brand name of this unit was.

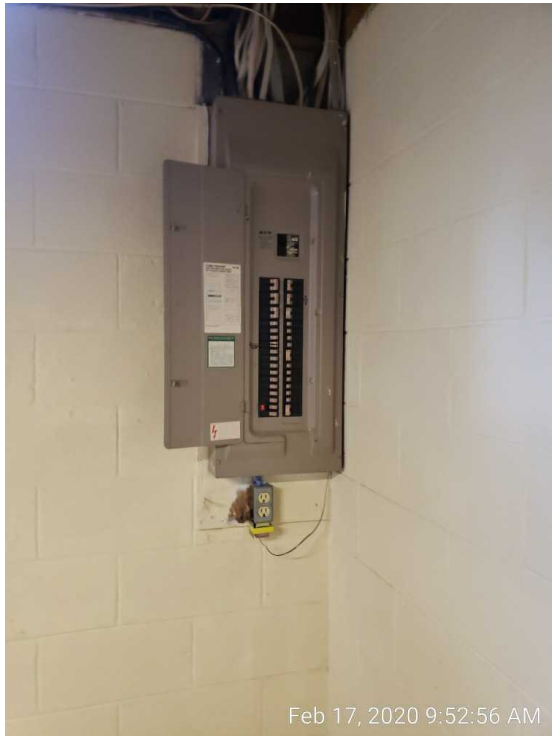
METER & PANEL LOCATION

The electric panel was located in the basement of the building.

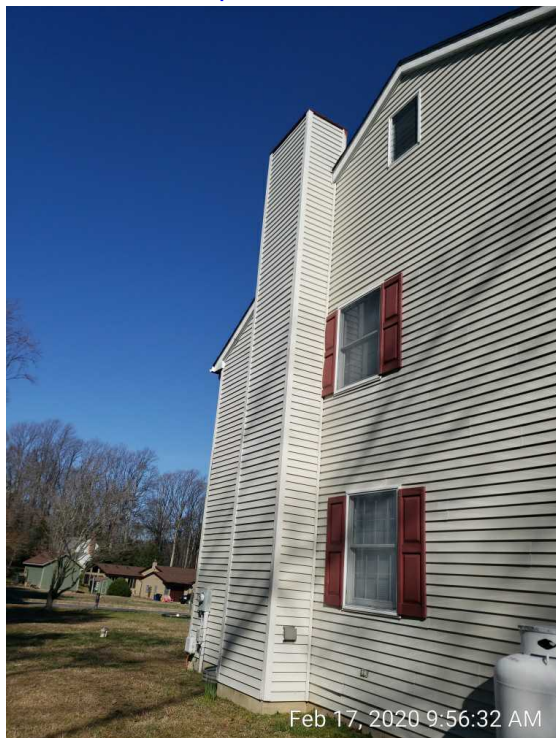
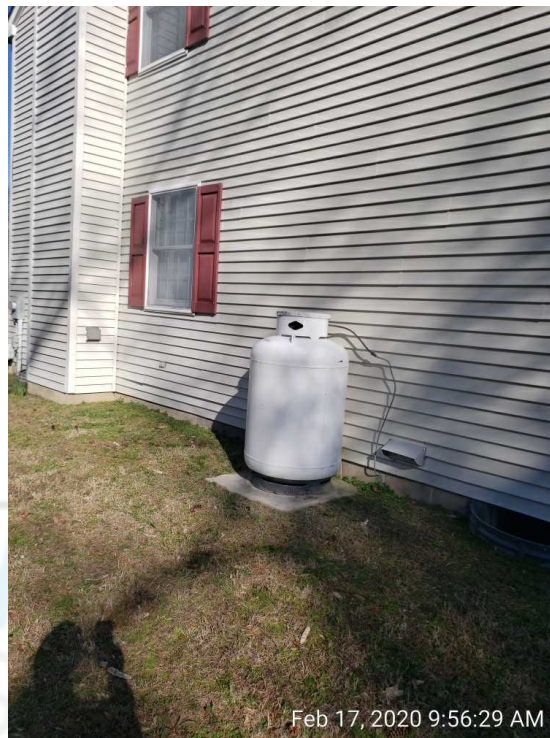
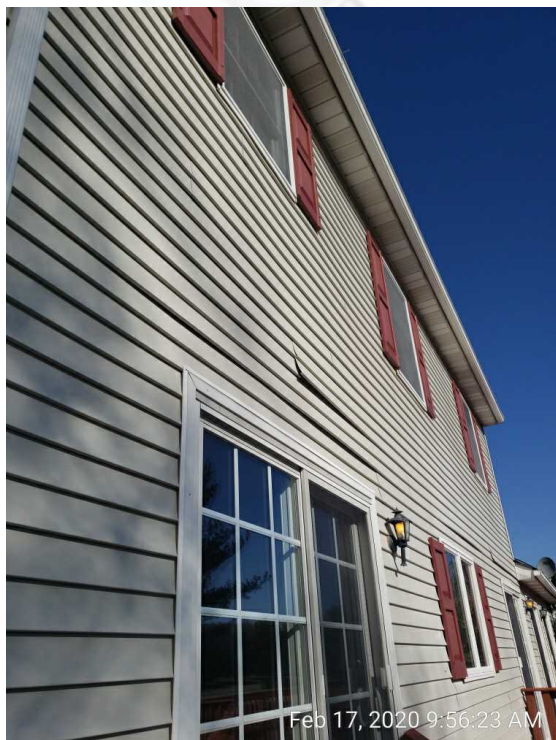
REPA Loose siding was observed at the exterior wall surfaces. Attention to the loose siding and/or damage is required to keep out water intrusion and pests. We recommend repair to current industry trade standards as required.

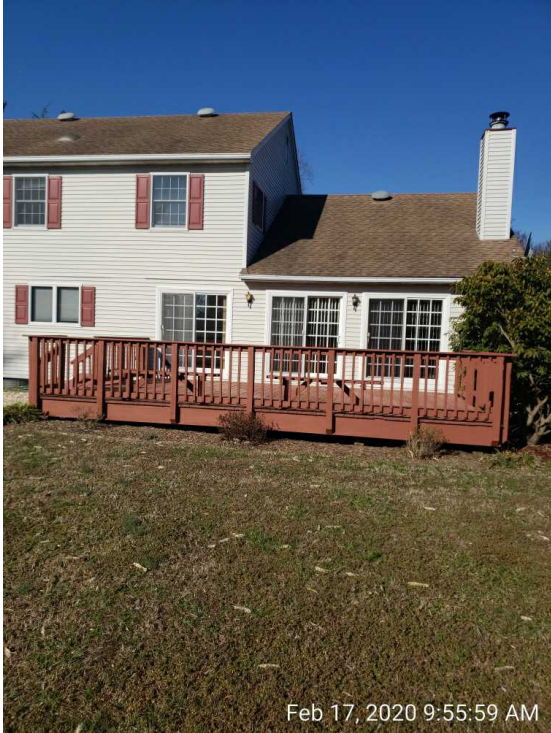
DECK SURFACE

The deck surface was constructed of wood.

The visible deck and support structure was generally in an acceptable condition. Regular maintenance will ensure maximum service life.
