Home Inspection:

**6 Non Such Pl
New Castle, DE**

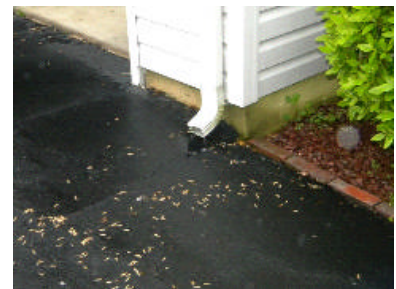
The building has gutters or scuppers located on all sides of the rooftop perimeter that discharge runoff. The building's roof drainage system consisted of drip edges at all of the roof runoff perimeters. The roof drainage systems appear to be in generally acceptable condition however, they should be checked on a regular basis. The gutters appear to be in generally acceptable condition however, they should be checked for debris on a regular basis. Gutters and drains are often ignored, and leakage from them can cause significant damage to the house and foundation. Unless it is raining during the inspection we may not be able to see signs of such leakage. Gutters and drains need regular maintenance and cleaning to make sure that water flows through the system and then well away from the house. For some houses the gutters need cleaning several times per year (depending on landscaping).

Maintenance: The downspouts of the gutter system should be routed away from the buildings foundation. We recommend that the runoff be directed six feet away from the foundation. **Repair:** Sections of the gutters were damaged on one or more sides. We recommend that all damaged, rusted or rotted gutters should be repaired or replaced in accordance with industry standards.
